2. Aerial view of the Neptune Yard site in 2013, viewed from the west, showing the excavation site (arrowed), cleared of buildings prior to excavation and with the Ship Inn, site of the Segedunum Roman bathhouse, still standing 100 metres east of the waggonway site.

3. Plan of the Neptune Yard 2B Site (dotted red outline) showing the evaluation trenches excavated in May 2013 (red fills) and the principal site of excavation (purple fill).

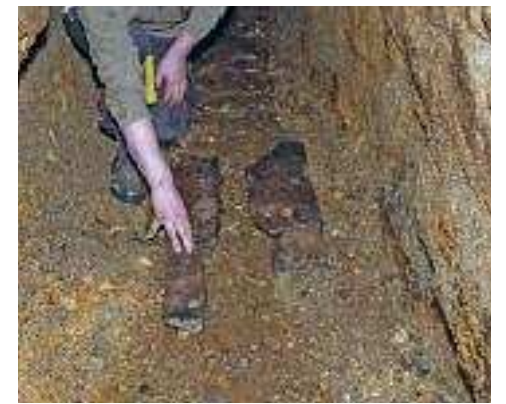
5. 'Hund' track remains, Caldbeck Fells, Cumbria in 2006 (in Gwynne 2009).

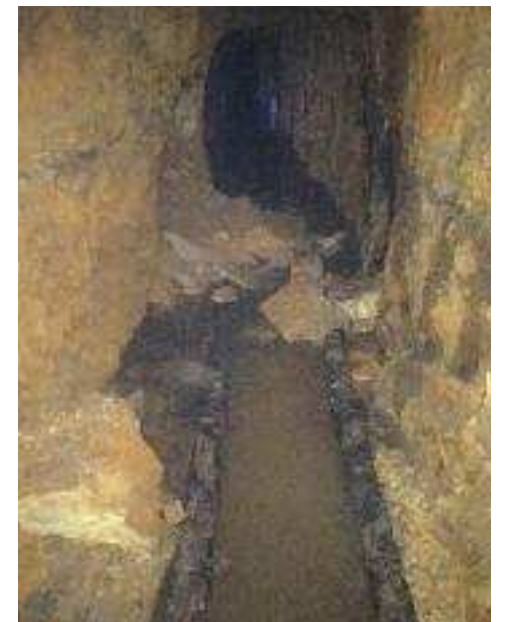
6. Wooden rails of a narrow gauge mineral railway in the Low Bottom Level on the Gilderdale burn, North Pennines photographed in October 2017.

The type of waggons used on these early waggonways is not known, but probably evolved from the standard coal wains used at the time. Later, the hopper body evolved as the best shape and the North East chaldron measure for coal became a standard measure with waggons built to take that load. The construction of waggonways changed relatively little during the remainder of the 17th century and into the 18th century, although the early single-track routes was replaced by the mid-18th century by a two-track system, with a main way for full chaldrons on their way to the staiths and a by way for the returning empty vehicles. Eighteenth century experiments with an L-shaped iron rail system and unflanged wheels - a now-redundant system known as a plateway - did not succeed but the introduction of flat iron plates in the later 18th century, fixed to the top of wooden rails in order to preserve them was more successful and led, ultimately, to the introduction of more resilient iron rails which came to replace wooden rails, a process hastened from around 1810 by the development of heavy steam locomotives. Wooden waggonways did not entirely die out at this time, however, since many already in existence, as at Lambton 'D' pit near Sunderland, continued in use for several decades while others were built for local mining operations throughout the 19th century and into the early part of the 20th century, as seems to be the case with the newly-discovered Gilderdale Low Bottom level waggonway near Alston in the North Pennines (Illus. 06 and see TAP 2017).

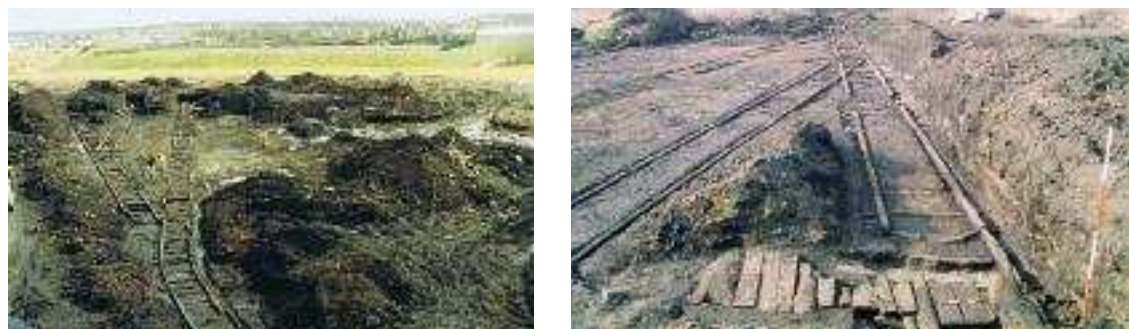
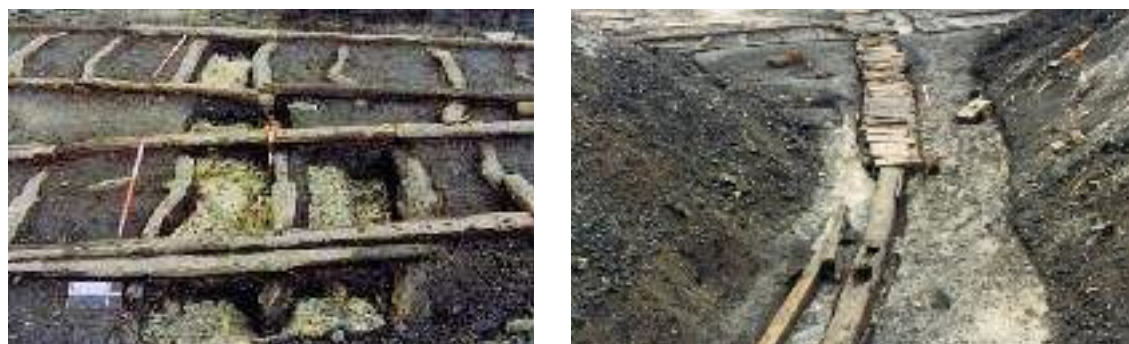
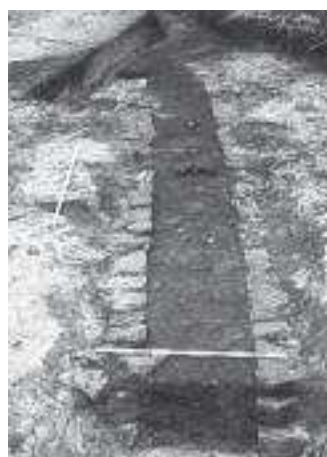
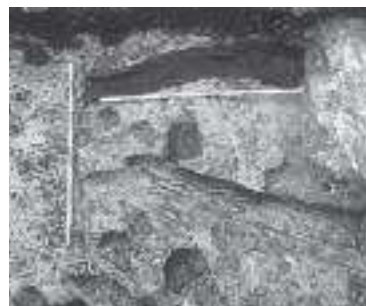
*From top, left to right:*  
 7. Lambton 'D' Pit Waggonway - general oblique aerial view.  
 8. Lambton 'D' Pit Waggonway - general view of tracks.  
 9. Lambton D - detailed view of rails and sleepers.  
 10. Lambton D - drain comprised of various wooden elements  
 11. Stone-lined drain; looking north. (Glover 2005, Figure 8)  
 12. Timber sleeper and sleeper impressions; looking west. (Glover 2005, Figure 9)

The wooden remains of the Lambton waggonway probably date to the period 1812-17, but could have been in operation as late as the 1830s and may be set on a track-bed dating to c. 1790. It is presumed that the waggonway was operated using horse-power - although no horse-related remains were found - pulling chaldrons which the authors presume were by that time iron-wheeled, "wooden wheels being rarely, if ever, heard of after about 1790" (op. cit. 20). The single-way wooden tracks were laid at 4 foot 3 inch gauge on a bed of ash and coal fragments in shallow trenches cut in the natural sub-soil, with ballast between the sleepers (op. cit. 17). The rails were mainly of oak with fir, ash and elm also in evidence, cut to 1.25-3.3 m lengths and generally around 0.12-13 m square. Many had coal and other grits pressed into their upper surfaces and all were drilled and pegged to the underlying sleepers with square and round wooden dowels. The sleepers themselves were of oak, 1.7-2 m long, mostly selected for straightness but, because many are not, they are erratically spaced between 0.4 and 0.85 m. The character of rail

construction suggested to the excavators a pragmatic, 'make-do-and-mend' approach involving continual re-use and replacement of timbers, with evidence of in situ wood-working seen in the presence of wood shavings, discarded dowels and timber off-cuts across the site. In the absence of double-rails or built features other than the rails and track-bed, the most interesting feature of the Lambton waggonway was the presence of crude points (op. cit. 13), lacking moving parts like those on the Bersham Ironworks found in 1990 and 1991 and probably operated using "a moveable blocking piece inserted into the flangeway where the diverging rail began", thereby guiding the wheels onto the desired rail, aided perhaps by the lateral pull applied by a horse walking on the outside of the track (op. cit. 20). Other features of interest associated with the Lambton tracks included the presence of several large square timber baulks of unknown function sunk into the boulder-clay beside the tracks (op. cit. 17), and drains of various types; one seven

metre section is formed of brick side-walls covered with timber off-cuts, running into a run of hollowed-out tree trunks (perhaps recycled parts of a mine pump mechanism). Despite the well-preserved nature of the tracks and associated features, associated small-finds were sparse, restricted to *relatively few shards* of pottery, glass and clay pipe of late 18th and early 19th century character, though none of them were found below the sleepers to give a date for the foundation of the waggonway..

The sleepers and rails of the tracks had largely been removed, probably for recycling, upon the abandonment of the waggonway, leaving only coal-filled sleeper impressions. These remains suggest, however, that sleepers were irregularly-shaped (see Illus. 12) and up to 1.90 m long by 0.18 m wide. Two relatively intact lengths of sleepers made from roughly-trimmed oak branches were recorded in situ; one displayed dowel holes at either end 1.42 m apart, giving an estimated

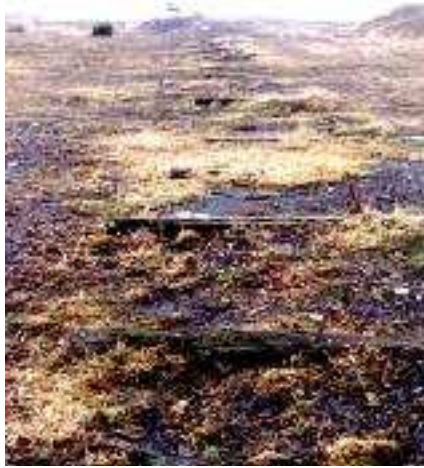
13. Wooden sleepers of the latest phase of colliery railway at Weetslade, North Tyneside. Carlton 1998

Fieldwork here included excavation of the Brunton and Shields Railway which opened in 1826 and operated as a colliery railway until 1980. Two phases of track-bed were revealed, both dating to the first half of the 19th century; the original 1826 line subsequently being relaid in 1839 for the use of locomotives. Clear evidence was found for the construction method of both the 1826 and 1839 tracks, showing that the original waggonway was built in a cutting, 7-8 m wide and up to 1.35 m deep in the clay subsoil. No remains of sleepers or rails were found, but the remains of the track bed comprised carefully laid ballast layers of slag, shale and coal, while the cutting had shallow drainage ditches along its north and south sides. Also investigated were the remains of a later track, using individual stone sleeper blocks probably corresponding with the re-laying of the line in 1839. The excavation has shown that, despite continual use of the line for over 150 years, significant remains survived of the earlier track-beds, the depth of the cutting being the principal factor in their preservation. The remains of the latest phase of colliery railway represented on the site was previously photographed in 1998 (Illus. 13 & 14; Carlton 1998).

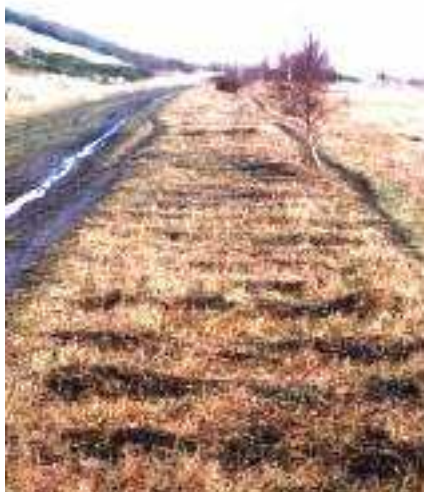
14. Undulations in a former trackbed where sleepers have been removed from a former colliery railway at Weetslade. Carlton 1998

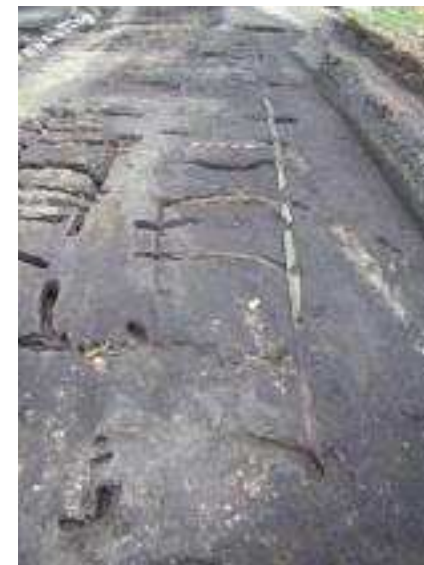
15. Track remains of the Harraton Colliery Waggonway near Washington (PCA 2010: Plate 9 - Area A, view of Waggonway [180] looking south). Photograph courtesy of Pre-Construct Archaeology

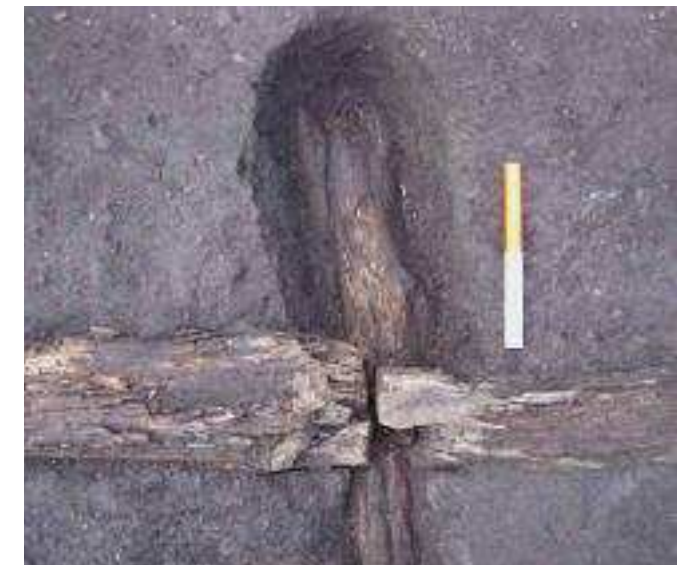
16. Detail showing two rails pegged into an irregular sleeper on the Harraton Colliery Waggonway (PCA 2010: Plate 11 - Area A, Rails 217 and 218 on sleeper 193 in waggonway 180). Photograph courtesy of Pre-Construct Archaeology

The earliest remains comprised a built clay embankment of dumped clay, the upper part c. 4m wide with a track bed up to c. 1.80 m wide; two timber sleepers, one identified as oak, survived from the track, with the remainder represented by impressions (see Illus. 18) A possible trackside gully was recorded along the eastern side of the embankment. The remains of the second early waggonway survived to the east as a group of sleeper impressions, along with five surviving sleeper timbers, all being crudely worked branches (Illus. 15 & 16). A later, perhaps late-18th century, waggonway used redeposited natural clay beds more than 1.0 m thick to carry the track which comprised sleeper and rail impressions, along with more than 20 surviving oak sleepers and one surviving rail. Further west, another forty timber sleepers survived along with numerous sleeper impressions with a gauge of c. 5 feet indicated by traces of rails. The remains of trackside ditches were recorded along both sides of the waggonway embankment. The latest timber waggonways, of late 18th or early 19th century date, followed the same NW-SE alignment as the earlier routes. Enhanced drainage was provided in the form of a brick-walled culvert (Illus. 17) associated with ground-raising deposits infilling the earlier waggonway ditch. The tracks survived as sleeper and rail impressions with more than twenty timber sleepers and eight timber rails of variable length evident; many of the sleepers with peg holes. The latest phase of the waggonways from the first half of the 19th century was poorly represented, but stone blocks found may represent sleepers for iron rails, each with two fixing holes in its upper surface.

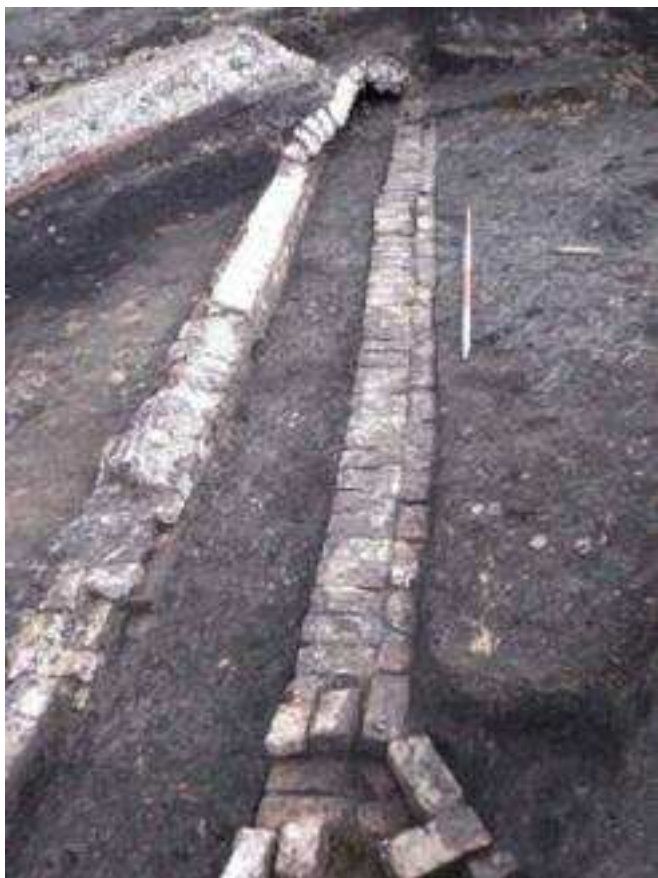
18. Track remains of the Harraton Colliery Waggonway near Washington (PCA 2010: Plate 18 - Area B, Trackbed [318] of waggonway [279] looking north). Photograph courtesy of *Pre-Construct Archaeology*

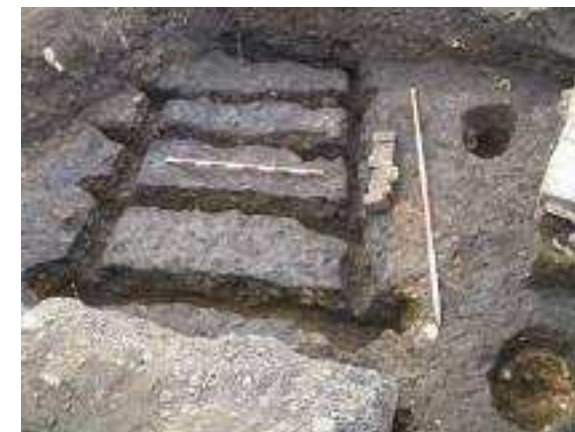
19. Track-bed impressions of the former 'Gateshead Ironworks' waggonway excavated at the former CPS Haulage Site, Hawks Road, Gateshead (PCA 2011: Plate 2 - Phase 3 waggonway [1131], looking south-west). Photograph courtesy of *Pre-Construct Archaeology*

The site, located in the historic 'New Greenwich' area on Gateshead's South Shore, was developed in the mid-18th century by the industrialist William Hawks for his iron manufactory, and later it became known simply as 'Gateshead Ironworks'. Two sections of a hitherto unknown timber waggonway were recorded running on a NE-SW alignment across the south part of the excavation area, with sleepers and rails visible as deep impressions in the underlying ballast (Illus. 19). Artefactual and cartographic evidence indicates that it was probably in use sometime after 1772 and may have been a branch line from a main waggonway leading to staiths on the Tyne. The earliest element of waggonway was a linear cut, c. 0.30 m deep created to make a level platform for the track by terracing into the naturally sloping ground. The track survived as a series of negative impressions of split-branch sleepers in a layer of compact sand and gravel - pottery recovered from the ballast comprised glazed red earthenwares and refined whitewares, datable to the late 18th or 19th century. Several post-holes, one associated with a shallow, 0.14 m wide slot running approximately parallel to the waggonway, are probably part of a fence-line associated with the wayleave of the waggonway. Two NE-SW aligned rail impressions were recorded within the secondary ballast, one measuring 3.30 m and 0.15 m square, the other 2.80 m long; the distance between the inner edges of the rail impressions was around 1.30 m or c. 4 feet 3 inches. Immediately to the north-west of the north-western rail impression were the remains of small brick structure, comprising six partial bricks laid parallel to the rail impression and probably associated with it.

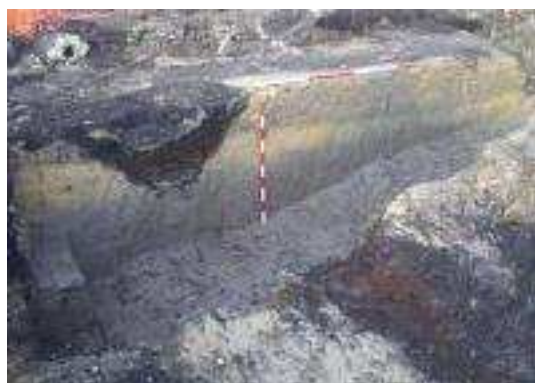
20. Remains associated with the Walker Colliery Waggonway excavated at Sir Charles Parsons School, Walker in 2011 (PCA 2012: Plate 6 - Area 1, south-east facing section across clay embankment [49] and trackside ditch [75], looking north). Photograph courtesy of *Pre-Construct Archaeology*

Excavation in 2011 on the site of a colliery waggonway of late 18th-century origin associated with the Gosforth and Delight Pits of Walker Colliery revealed remains of a substantial clay embankment 27.60 m long by up to 7.60 m wide and up to at least 1.11 m high. Although no timbers survived, the impressions of sleepers and rails were recorded, as well as postholes representing fixings, across the upper portion of the embankment, along with a small assemblage of finds of 18th- & 19th-century date. The sleeper impressions suggest that they were hewn from roughly-trimmed branches up to 1.17 m long, but as only one rail impression was found, the gauge of the track could not be determined. Parallel trackside ditches 3.2 m apart, indicating that it was a single-track route, were up to 0.80 m wide and 0.50 m deep with vertical sides and flat bases, revetted in places with stakes which would have supported timbers (Illus. 20 & 21). On one side at least, as at Rainton (Glover 2005, 238-9) a double-ditch system seems to have been used, perhaps in response to particular drainage conditions, caused by the high embankment, or representing different phases of use. Other post- and stake-holes, 0.04 - 0.10 m in diameter, set in the base of a ditch, broadly forming two rows, are interpreted as representing a simple bridge across the ditches and a fence line alongside. The later development of the waggonway, probably during the late 18th or early 19th century, was represented by material dumped on the embankment at a time of trackway upgrade to stone sleepers and iron rails.

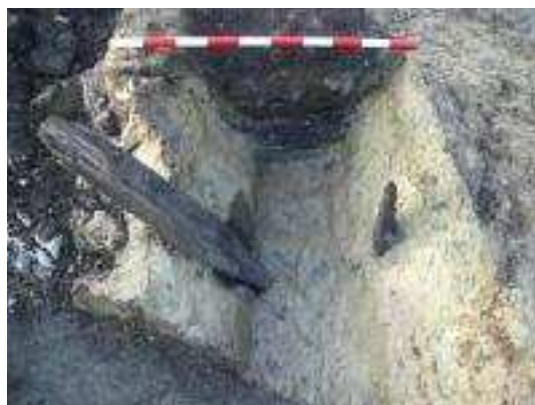
21. Remains associated with the Walker Colliery Waggonway excavated at Sir Charles Parsons School, Walker in 2011 (PCA 2012: Plate 8 - Area 2, ditch [8] and re-cut [5], showing stakes [4], [15] and [16], looking south-east). Photograph courtesy of *Pre-Construct Archaeology*

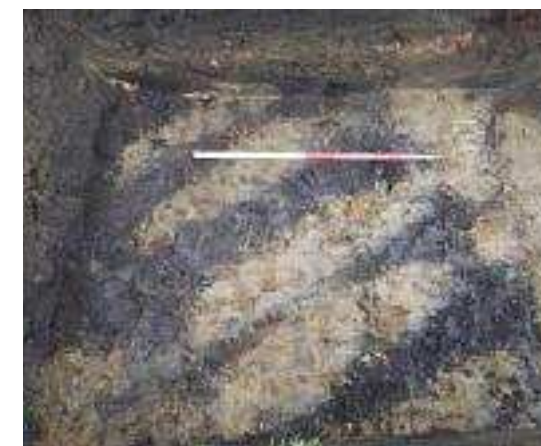
22. Sleeper impressions on the line of Jane Wharton's waggonway at Coaley Lane, Newbottle, Houghton le Spring (ASDU 2016, Figure 11: Sleeper impressions [F54] at the west end of Trench 9, looking north) Photograph courtesy of *Archaeological Services Durham University*

Evidence for the sleepers of an early waggonway track (Illus. 22), probably part of the line of Jane Wharton's waggonway, with associated trackside ditches and track bedding, was exposed in the south part of the site. Elements of two later post-medieval tracks were also revealed elsewhere.

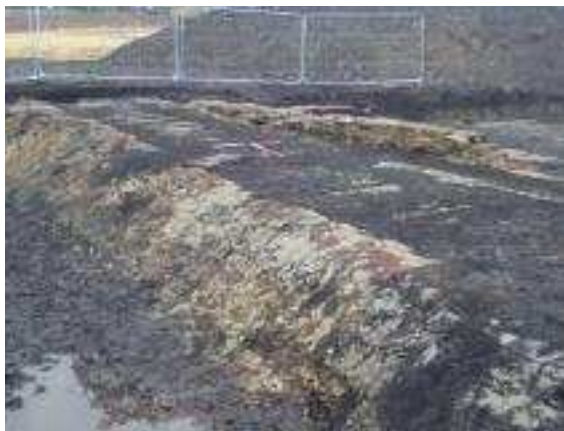
23. Waggonway remains uncovered at Redburn Row, Chilton Moor, Houghton-le-Spring (ASDU 2017: Figure 16 - Waggonway embankment [F221], facing north). Photograph courtesy of Archaeological Services Durham University

Archaeological excavation at Redburn Row, Chilton Moor, Houghton-le-Spring uncovered two, probably contemporary, waggonway tracks, one on a substantial embankment up to 7.1 m wide and 0.9 m high (Illus. 23), the other parallel to it to the east and unembanked. The lower track had irregular sleepers (Illus. 24); the upper one had regular ones which appeared to have replaced an earlier, more irregular set. The remains of two phases of a coal depot, comprising buildings and a culvert, were found associated to the south-east, along with housing, while the artefactual assemblage from the site dated from the 1780s to the 1950s. Along the crest of the embankment was a series of track impressions formed by the lines of both rails and sleepers bedding into the underlying clay and filled with a mixed deposit of black silty grit with frequent inclusions of ash and occasional brick fragments. The sleepers varied in form, with some regular, similarly-sized beams laid at right angles to the rails, but others more sharply angled, irregular and curvilinear. It is considered by the excavator that these reflect two phases of track, with the more uneven sleeper impressions relating to the earlier phase. No physical remains of the track or any track bedding were observed. The main ditch, 3.1 m wide and 1.15 m deep, flanked the east side of the embankment and had a more rounded base than the west ditch. A stone culvert, 0.78m wide, 0.45m high, cut through its fill, its walls of angular sandstone blocks and with a capping of sandstone slabs. A second, later waggonway track was present between the wayleave and trackside ditches, with elements of both bedding and iron-railed track surviving.

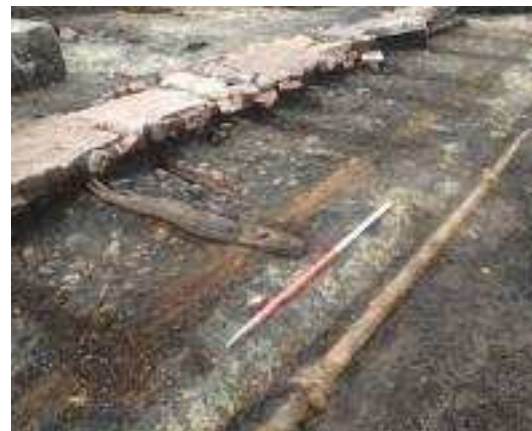
24. Waggonway remains uncovered at Redburn Row, Chilton Moor, Houghton-le-Spring (ASDU 2017: Figure 19 - Track [F164], facing west). Photograph courtesy of Archaeological Services Durham University

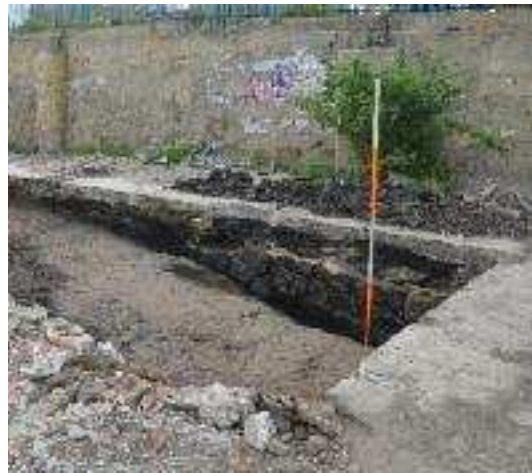
25. The west side of the Carville Hall boundary wall uncovered in May 2013.

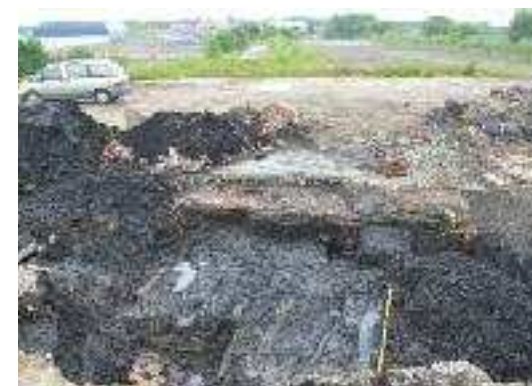
26. Sleepers uncovered on the east side of the Carville Hall boundary wall with the remains of a brick floor, part of the Tyne brickworks, on its west side.

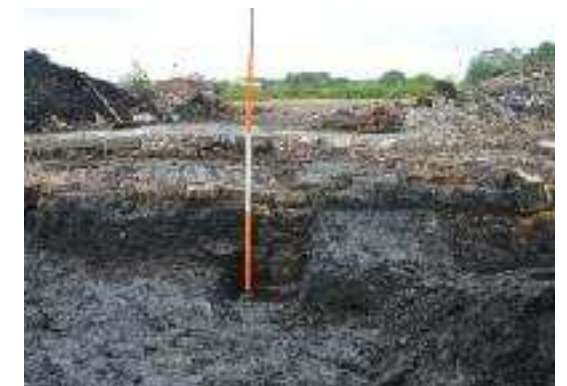
27. A test-pit cut against the east side of the boundary wall revealed timbers running transverse to the sleepers.

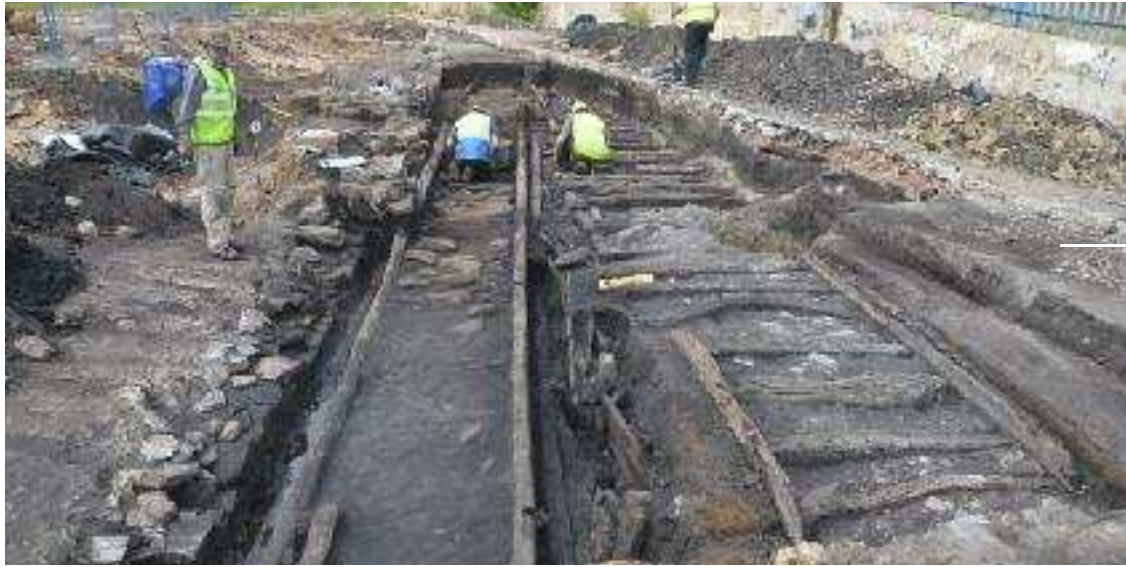
28. Excavation of the main way and horse-way siding with boundary wall overlying an earlier revetment wall. (see aerial view, below).

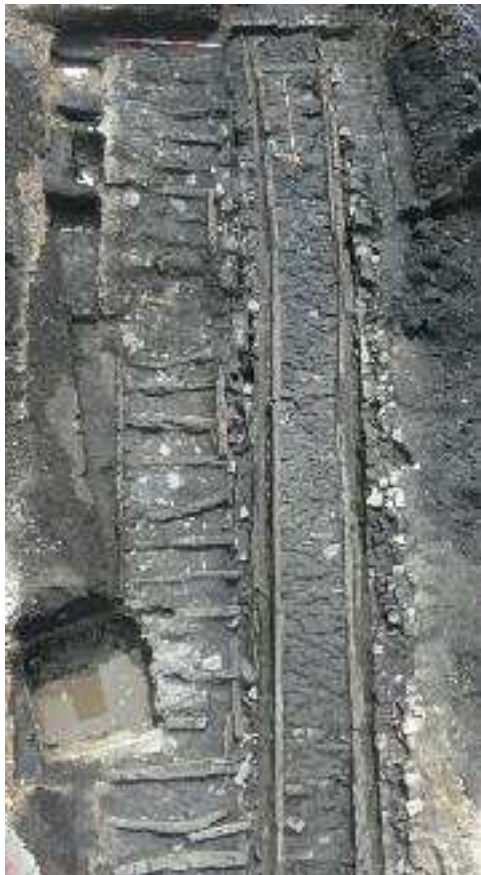
29. Carville boundary wall overlying an earlier revetment wall to the west (right of view), shown in an aerial view taken in July 2013.

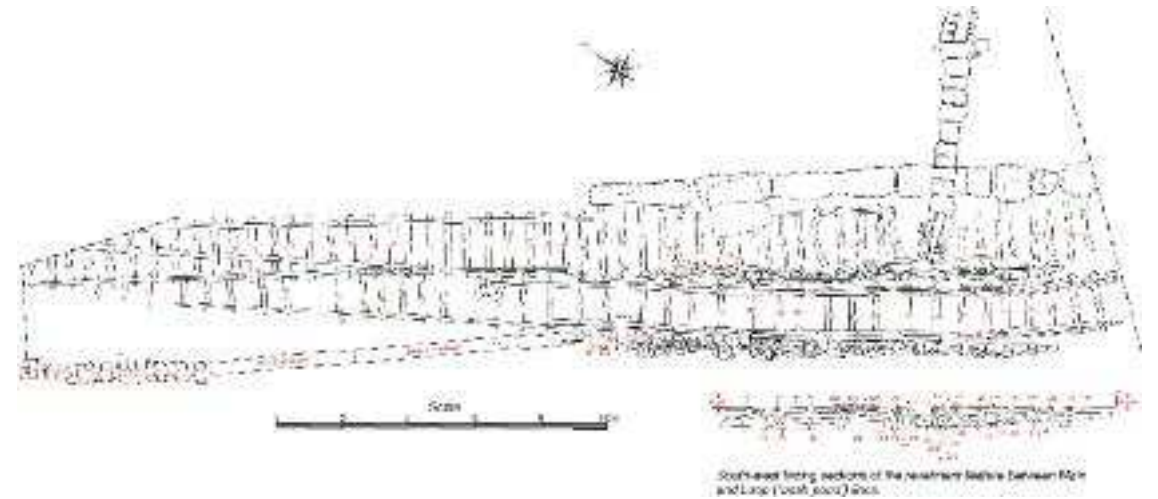
30. Plan and partial section of the waggonway remains uncovered at Neptune Yard in Summer 2013, showing numbered timbers.

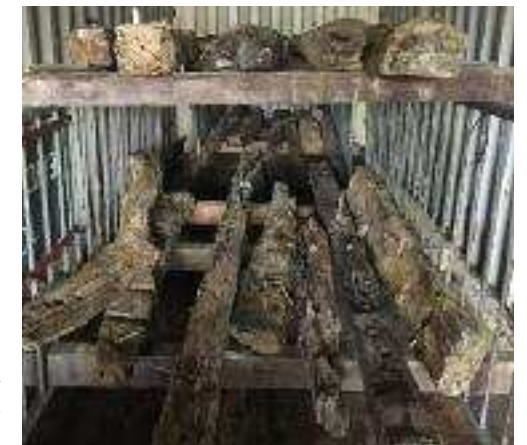
31. Timbers salvaged from the excavation site and removed to temporary storage at the Stephenson Railway Museum, North Tyneside in August 2013.

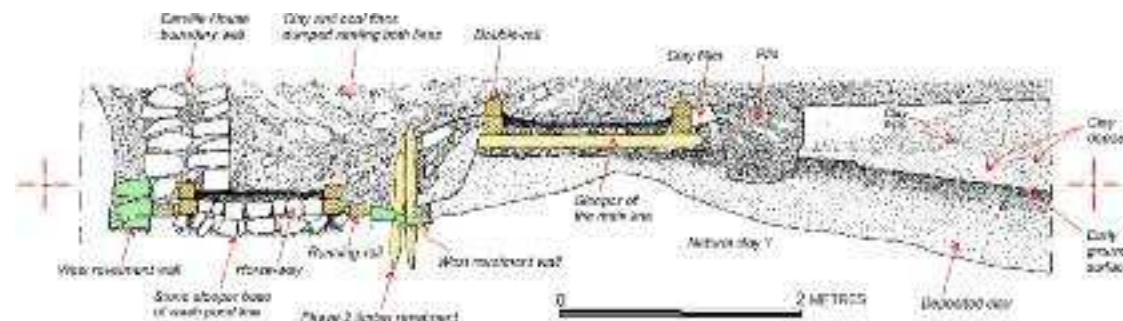
33. Drawing of a south-facing section across the waggonway showing its principal features, including cuts and embankments made into and from the pre-existing ground surface

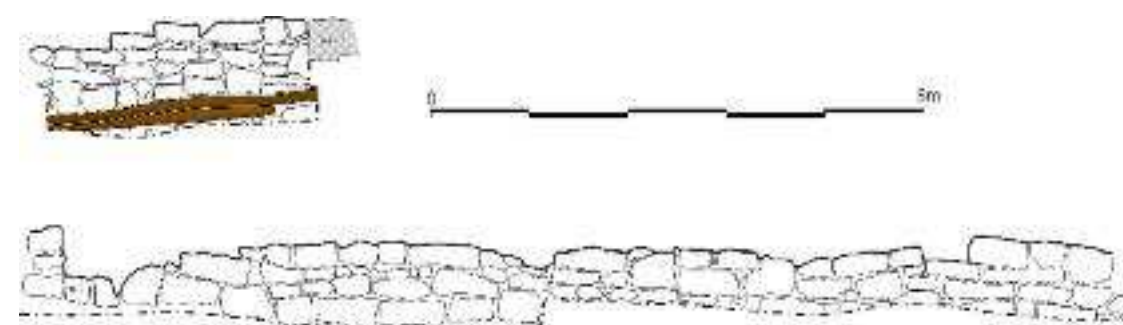
34. Part of the east-facing elevation of the Carville Hall boundary wall (above) and (below it) the north part of its west-facing elevation

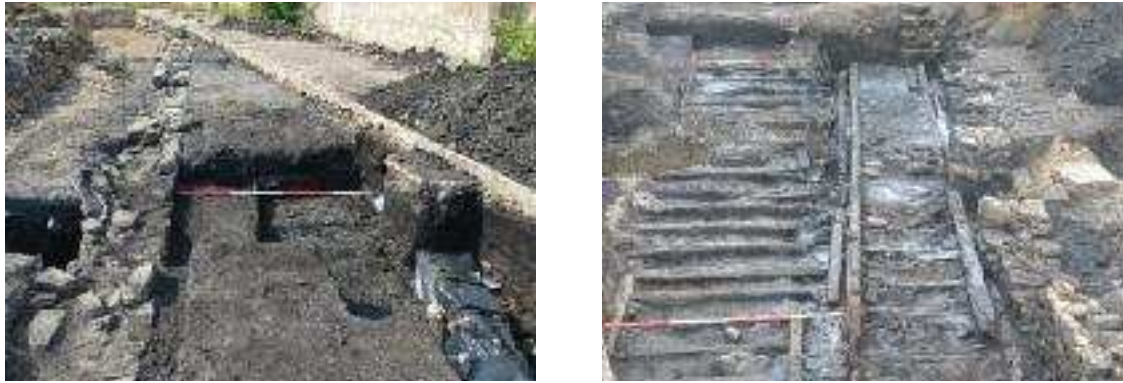
35. The Carville Hall boundary wall (*left*) running to the northern boundary of the site.

Close to its north end the wall sat upon the fill of a cut feature, interpreted as a wide ditch or west side of a cutting (see Illus. 35, at extreme left of view), the course of which is slightly askew to that of the wall, its west side running gradually away from the wall towards the south (riverside). A section cut into this putative ditch against the west side of the wall found it to be slightly concave, descending at an angle of approximately 400 from the vertical with a flattish base running under the wall which sat upon and within a fill of coal finings and dust. This cut feature running askew to the course of the wall was traced towards the south for some 12 metres at which point it ended, or was interrupted by a concrete pad and natural or redeposited clay sub-soil, and not picked up further south, although relatively little exploration of the area west of the boundary wall occurred in the south-west part of the site. It is possible that this feature was originally a wayleave ditch along the western flank of the main line, partially destroyed and infilled when the waggonway complex was remodelled with the construction of the siding; or it may have been a drainage or water supply conduit made obsolete by the formalisation of water supply by construction of the timber-capped leet described below.

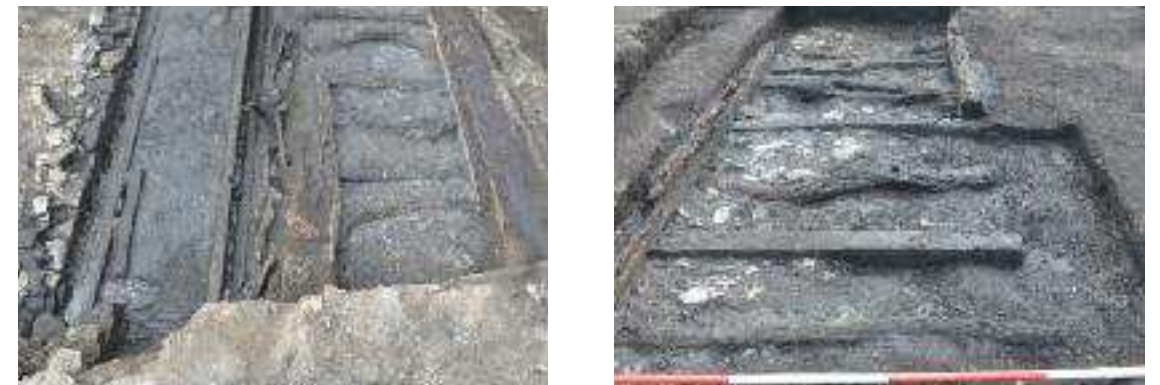
37 The Main Way and horse-way siding line, showing remnants of the boundary wall sitting over the upper rail of the horse-way, with an additional plank inserted alongside it to provide additional foundation. The west revetment wall is to the west (*left in this view*) of the siding.

The sleepers, which extended either side of the rails by between 0.07 and 0.47 m, were marked by their inconsistent nature – some being squared, many of them re-used ship timbers, others only lightly re-worked tree branches (see Illus. 37 & 38) - as also found at Lambton 'D', Rainton Bridge and other excavated waggonways sites in the region (see above). The sleepers, were spaced between 0.5 – 0.68 m on the main way and 0.55 – 1.08 m on the by way, with those in the wash pond averaging c 0.75 m. These spacings are towards the higher end of the spectrum provided by Lewis (1970) who suggests that main ways were generally constructed with their sleeper centres spaced between 0.30 m and 0.45 m, occasionally up to 0.61 m but only rarely outside that range, while by way sleepers were generally spaced at 0.61 m or more, with 0.91 m not uncommon. The sleepers were set in to a substantial bed of shale and yellow clay ballast and an additional bank of clay was laid along the external edge of the eastern rail, covering the sleepers extending beyond the rail. The latter perhaps marked a walkway alongside the waggonway or a means of deflecting water from the waggonway; there is no evidence to suggest there was ever a ditch on the eastern side of the waggonway.

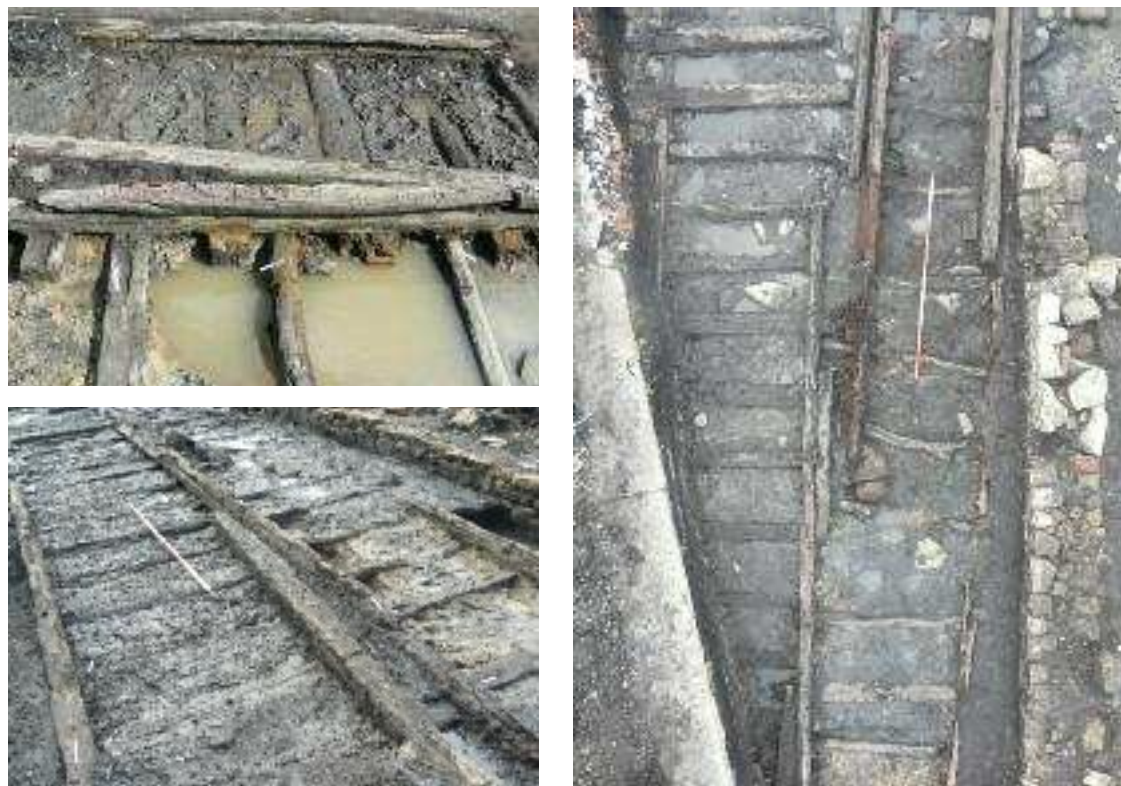
39 Double-rails on the main way.

At the north end of the excavated area, the main way and its wash pool siding converged at a set of simple points (Illus. 40 & 41), although the likely obsolescence of the siding prior to final abandonment of the waggonway means that the points themselves were not preserved sufficiently to allow analysis of their functional characteristics. The sections of upper rails were short here, however, suggesting that they had been more prone to damage caused by levering the waggons from siding to main way.

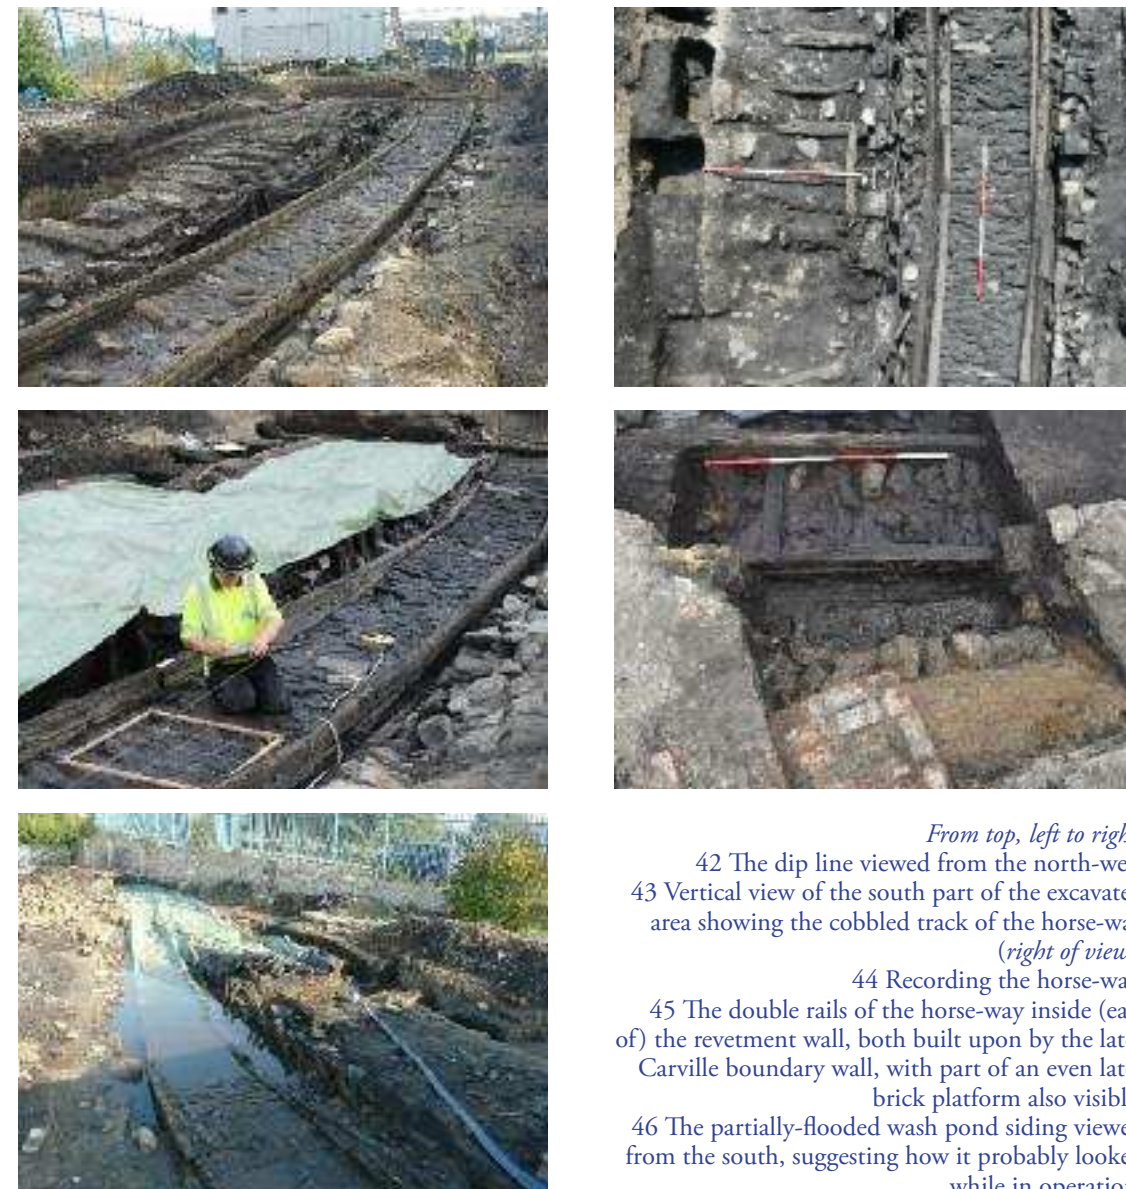
42 The dip line viewed from the north-west  
43 Vertical view of the south part of the excavated area showing the cobbled track of the horse-way (right of view).

A discrete area of flat cobbles and water-worn stones lay over the northern upslope end of the horse-way, which would have allowed the waggonway draught horses to gain some purchase as they pulled up the slope on what was an increasingly smooth surface. Over most of the walkway was a layer of compacted coal fines and coarse sand which, given its level of compaction, must have developed during the working life of the siding. These obscured the smooth upper surface of the cobbled horse-way which, in turn, entirely covered the oak sleepers of both the running rails and internal horse-way, which emerged only where the cobbled surface ran out on the rising slopes of the dip line.

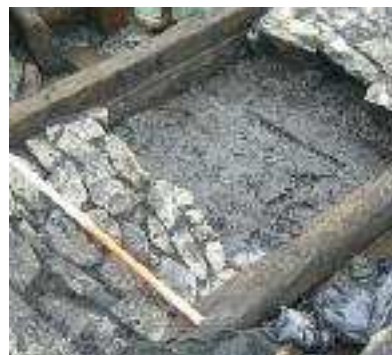
47 Part of the horse-way cobbled surface lifted to reveal well-preserved sleepers beneath.

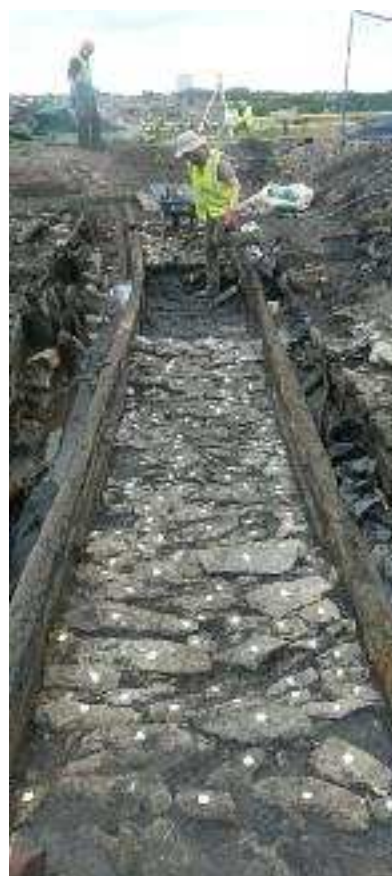
48 The stones of the horse-way marked during the process to remove them into storage.

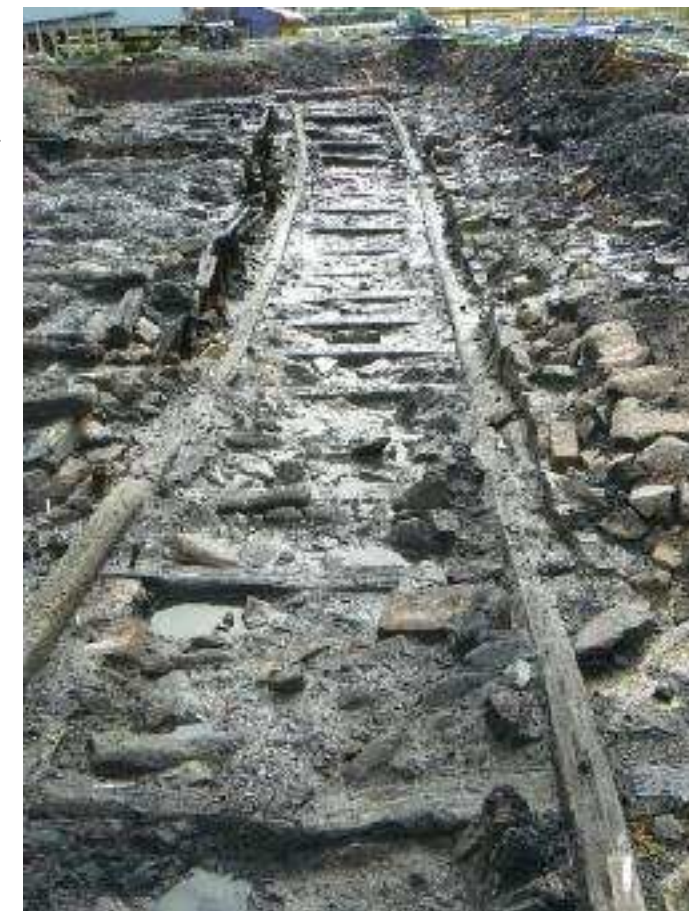
49 View of the siding following removal of the horse-way, showing the running rails pegged into well-preserved oak sleepers.

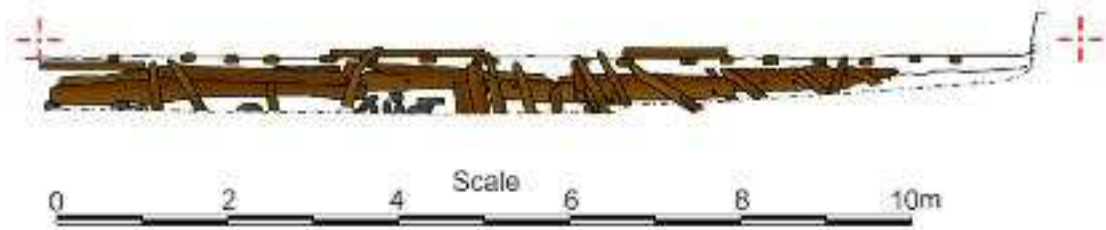
50 Elevation drawing of the wooden post & rail structure forming a revetment to the east side of the wash pool siding.

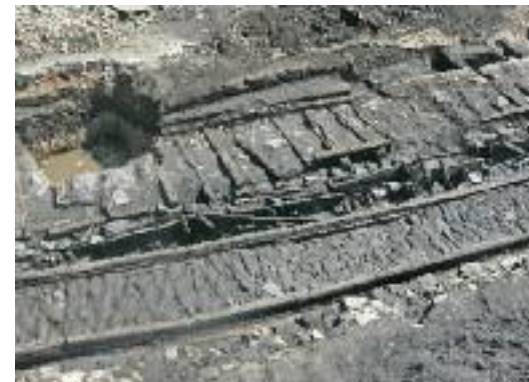
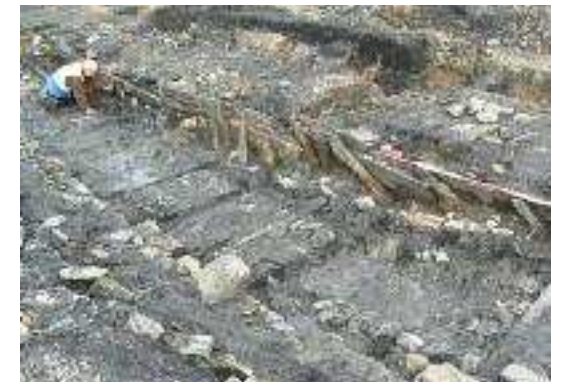
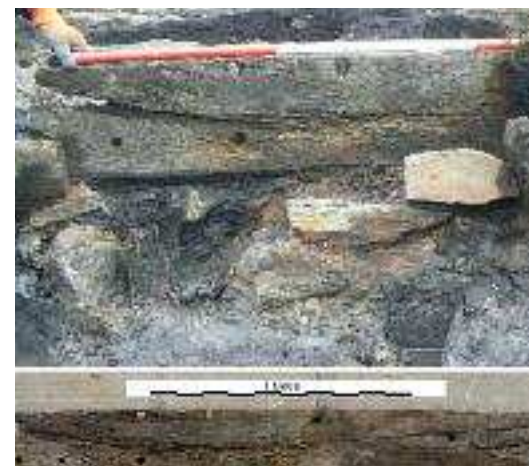
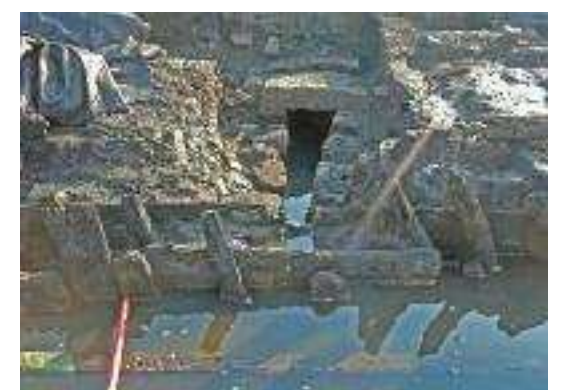
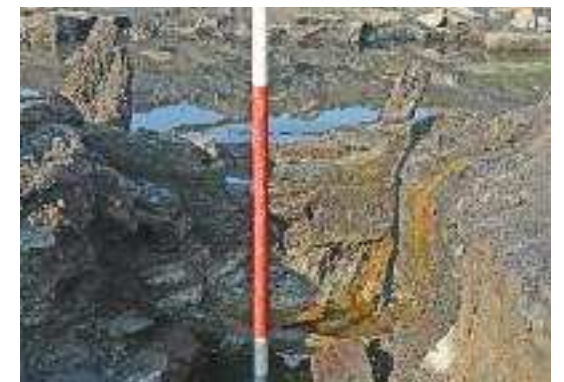
*From top, left to right:*

- 51 Oblique elevated view of the wooden revetment on the east side of the wash pool siding.
- 52 View of the revetment from ground level.
- 53 Plank (no. 125) forming part of the revetment, showing evidence of previous use as part of a maritime vessel.
- 54 View eastwards from the wash pond over the revetment and its rudimentary sluice used for water control.
- 55 View of the revetment from the drain to the west showing notches in the timber suggesting a sluice-like mechanism.

The post and plank revetment adjacent to the bottom of the horse way depression is formed by an unusually thick (0.06 m) plank, parallel with, but off-set by c. 0.20 m from, the main planking, supported on its outside by three, perhaps four, squared posts, with additional squared posts to the west suggesting that the feature once continued in that direction. Between the inner and outer planks is a deposit of pure, light-brown clay and a second layer of planking is just visible in the south section, suggesting that this clay-filled wooden feature is at least 0.43 m deep (although the back of the feature, the 'original' revetment planking, is some 0.10 m higher still). An exploratory cut made on the east side of this feature revealed more large stones and the remains of wooden rails or posts apparently parallel with, and representing earlier phases of, the revetment; it was clear that several phases of some kind of sluice arrangement for draining water from the 'wash pond' in the siding were represented here.

As noted above, the failure of the original retaining wall to the east side of the wash pond cutting led to the construction of a timber revetment along the same course as the wall, which was only incompletely removed. The revetment was formed of five horizontal re-used ships planks pegged with both rounded and squared timbers, the irregular spacing and orientation of which suggested more than one phase of installation. The inlet for the stone-built culvert draining the wash pool to the east was marked by a double skin of planks, a gap between which was filled with a pure grey clay.

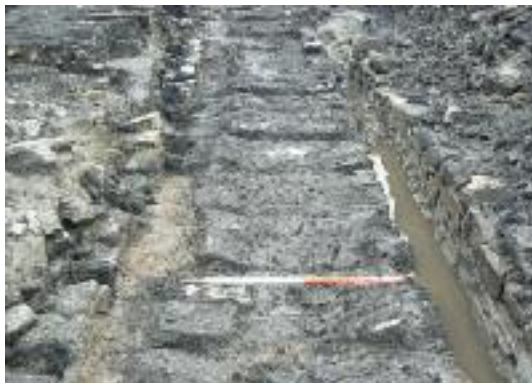
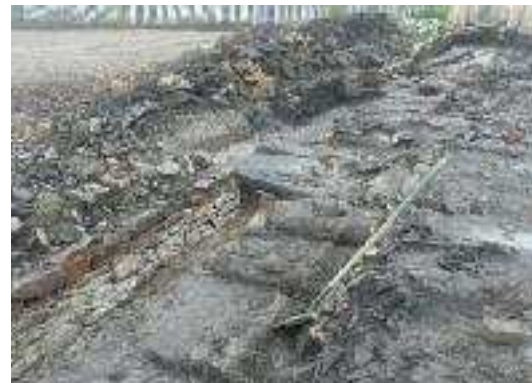
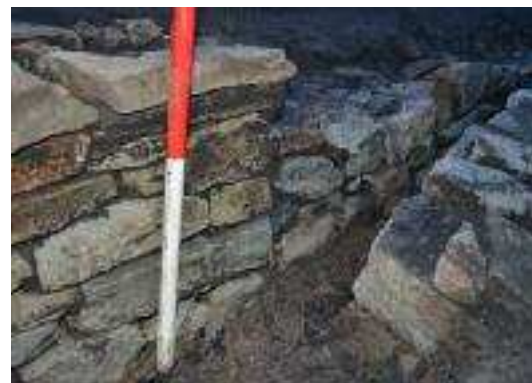
*Clockwise from above:*

57 The siding viewed from the north following removal of the horse-way and rail track, with the remains of the east side revetment wall and, on the west side of the track-bed, a water-filled leet bounded by the west side revetment wall.

58 View from the south-east of the west side revetment wall and its intersection with the leet, covered at its south end by shorter lengths of transverse wooden planking.

59 Leet capping removed to show dry-stone walling at the junction between the west side revetment wall and leet channel.

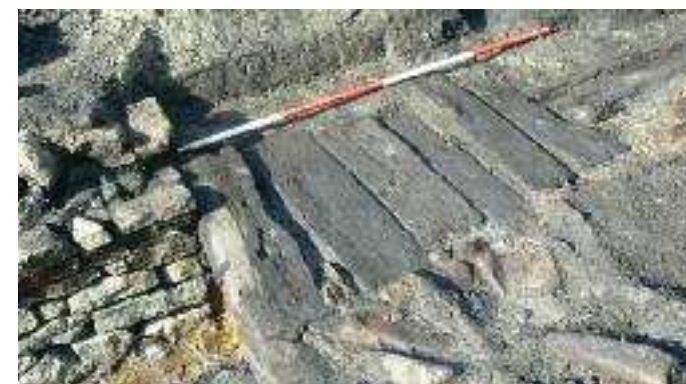
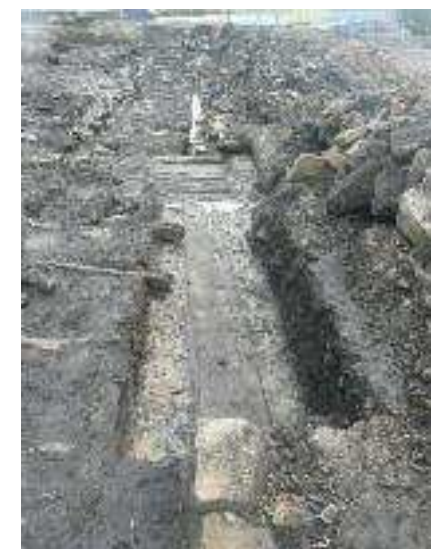
61 Transverse planking capping the south end of the leet.

62 6.75 m long reused ship's plank over the south end of the leet, with transverse planking beyond.

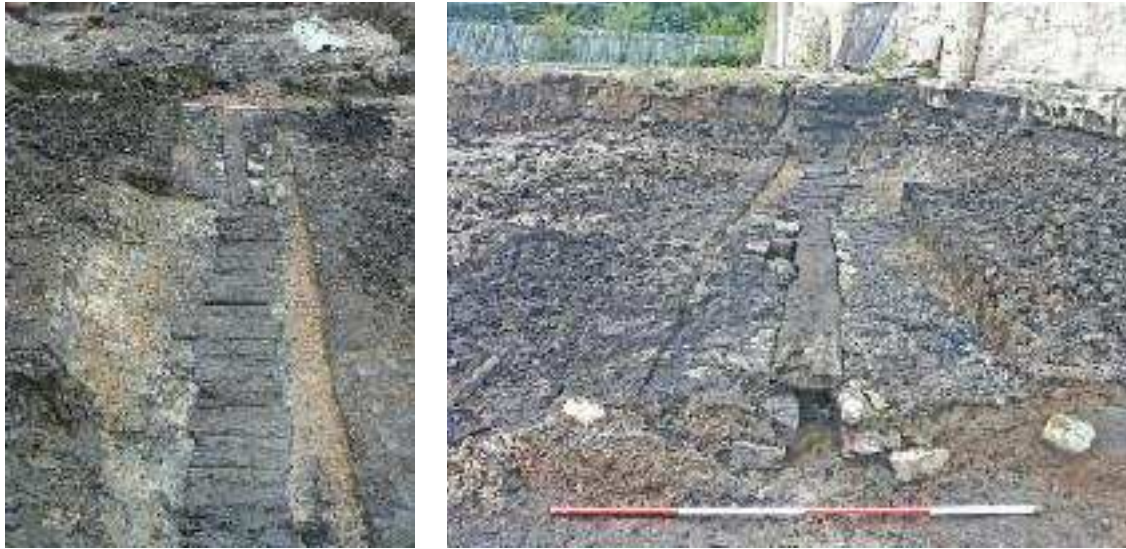
63 View from the north of transverse planking capping the north end of the leet within the excavated area, with a 4.46 m long plank sitting over the leet between transverse planking and a longer, 6.75 m long plank (removed in this view, but see above).
