2. Aerial view of the Neptune Yard site in 2013, viewed from the west, showing the excavation site (arrowed), cleared of buildings prior to excavation and with the Ship Inn, site of the Segedunum Roman bathhouse, still standing 100 metres east of the waggonway site.

3. Plan of the Neptune Yard 2B Site (dotted red outline) showing the evaluation trenches excavated in May 2013 (red fills) and the principal site of excavation (purple fill).

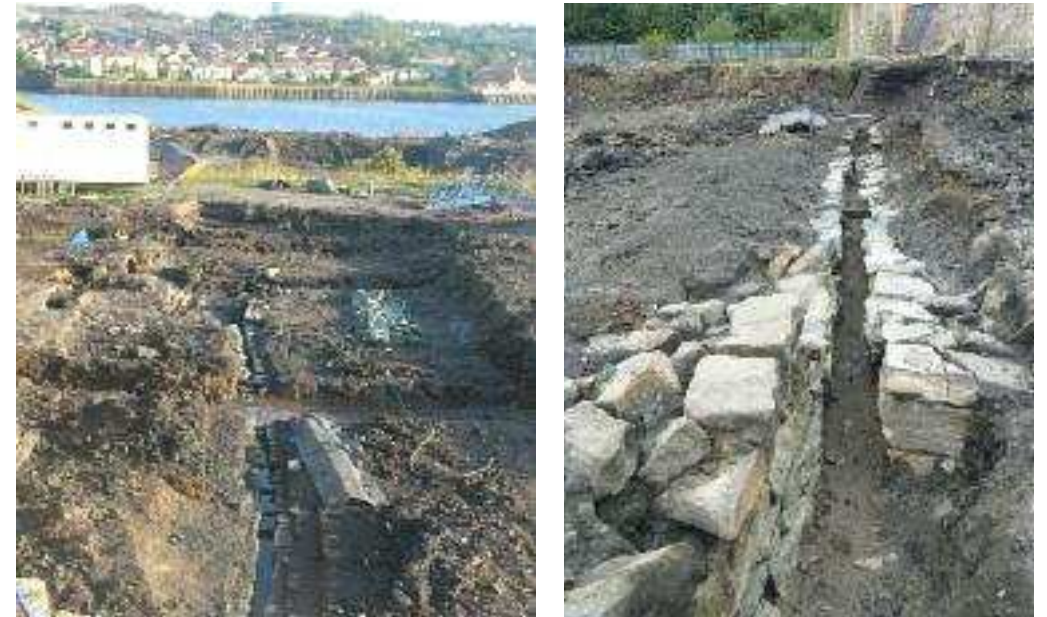
65 View of the course of the leet from the north, with capping removed.

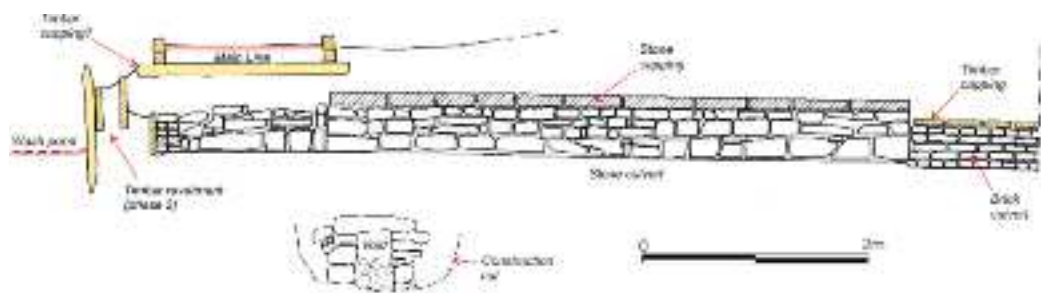
67 Section drawing of the south-facing elevation of the north side of the drain channel under the main line and east of the main line embankment/wash pool siding revetment.

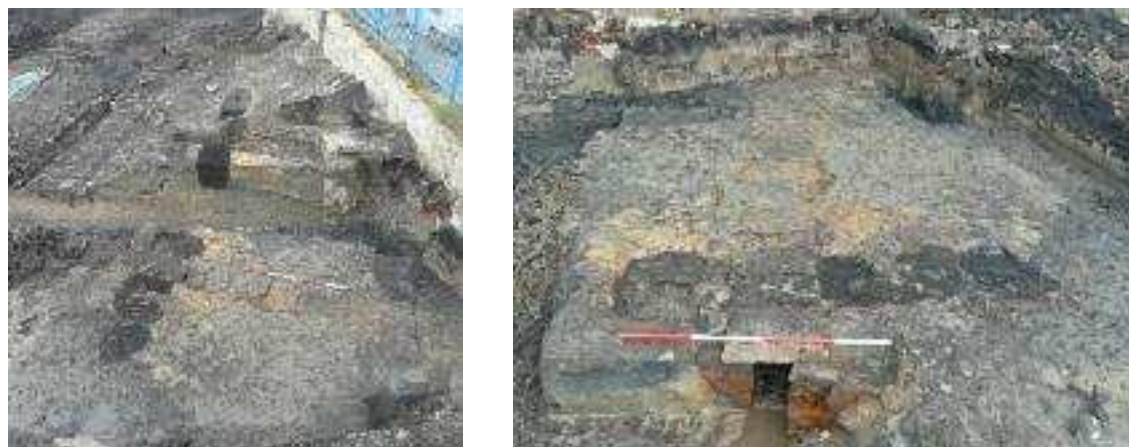
68 View from the south of the course of the drain across a line of pits parallel with the main way (track removed).  
69 View from the west of the course and west profile of the drain.

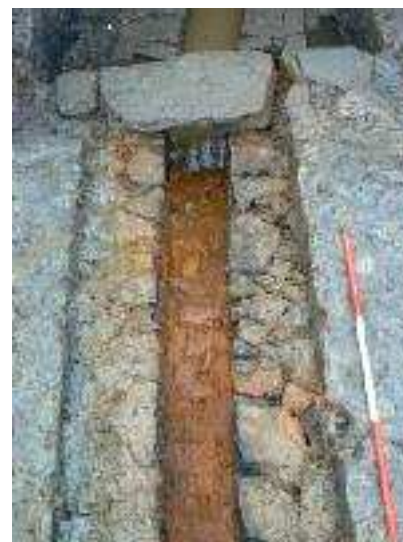
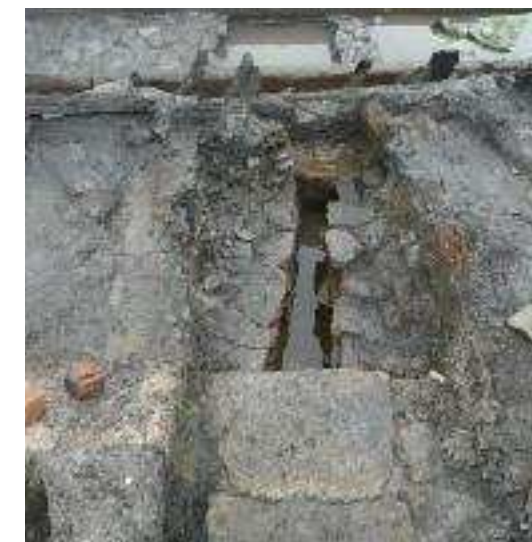
70 The course of the drain with capstones removed, showing iron-rich orange fill.

The drain is capped for most of its length by flat sandstone flags 0.16 m deep, up to 0.50 m long and up to 0.90 m wide (Illus. 70 & 71), but the capping had been removed over the final 1.5 m length of the west end (Illus. 71) where it underlay the main way and ran into the revetment. The likely reason for this is implied by slumping in the track-bed base seen in the adjacent south-facing section, probably caused by the downward pressure exerted by laden waggons,

causing the track-bed, drain-capping and, quite possibly, also the revetment to be rebuilt. Fragments of wood found in association with the uncapped west end of the drain suggest that the slumped stone capping slabs may have been replaced by timber planks, perhaps at the same time the east revetment wall was replaced by a timber post-and-plank structure.

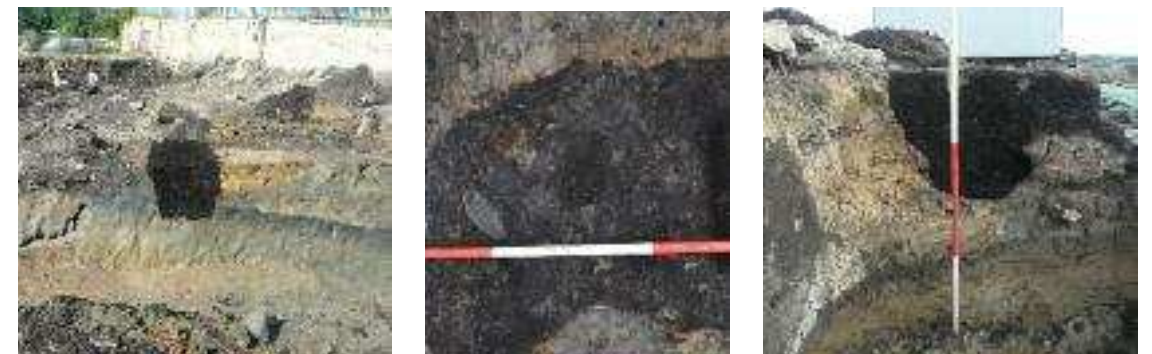
#### *From left:*

76 The south-facing section of a pit infilled with coal waste on the east side of the main way; note also slumping in the clay base of the main way which probably explains the re-laying of the latter and absence of stone capping from the drain underneath it. 77 Vertical view of one of a series of infilled pits on the east side of the main way. 78 North-facing section of one of the infilled pits

An eight metre section cut across the site through one of the pits, extending in total from the Benton Way site boundary eastwards across the main way embankment, revetment and siding to the west-side retaining wall, revealed a series of clay-based deposits underlying the pits, railway tracks and associated features. This south-facing section revealed an underlying base clay, brown in colour and somewhat coarse in texture, containing grit and small stone fragments but no obvious made material. This ran uphill from the east (from the bottom of the section south of the concrete pillar base adjoining Benton Way) until apparently peaking under the eastern edge of the main way before descending slightly and flattening to end under the west side of the main way bordering the revetment. Underlying the parallel horse-way within the wash pond siding is a cleaner clay extending to the west revetment wall, beyond which a similar clay to the original base material resumes, overlain by a much cleaner clay (cleaner and browner than that under the horse-way). Over the original gritty clay east of the revetment is a similar clean clay to that forming upper deposits west of the horse-way; this forms the base deposit for the main way, the sleepers of which rest upon a broken shale-like deposit mixed with coal finings. The top of the fine clay descends from the east side of the main way as a dark band, probably implying the presence of coal dust in the puddled upper surface, until reaching the concrete buttress c 0.40 m above the bottom of the cut at a depth of c 2.0 m bgl. Above the dark band east of the pit feature is a double raised undulation with a fillet of yellow clay infilling the raised undulation and east side of the pit. On the west side of the pit is another, different fillet of pure orange clay between the pit and main way. Apparent slumping of clay under the main way, presumably caused by the sustained and repeated trauma of heavy waggons moving across it, may explain the various phases of revetment on the east side of the siding cut, as well as the absence of capping stones from the western part of the drain underlying the main way (see Illus. 71 above).

At some point in the development of the route, a series of 'pits' was excavated along the eastern flank of the main way. These are currently poorly understood, but would seem to have formed a series of cells, demarcated by clay walls, possibly lined with timber. Their fills were fairly consistent throughout; coal fines and frequent pieces of pantile, but this almost certainly represents backfilling of disused features. Further analysis, archaeological and historic, has so far failed to elucidate the functional interpretation of these features. Palaeo-environmental analysis of their fills (see Appendix 1, below) revealed the preservation of a small amount of wood and uncharred seeds which reflects some anoxic preservation and could, though not conclusively, support the suggestion that the pits were used for water storage. Another proposed suggestion was that the pits may have been used for the storage of horse feed is not supported as plant remains associated with fodder, such as cereal remains, crop processing waste, grass/hay or weeds associated with hay, were absent from the samples.

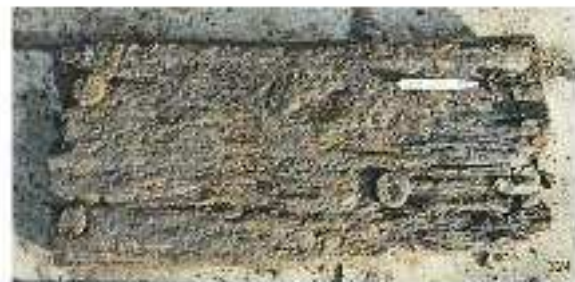
79-81 Timbers showing distinctive features of ship-building and waggonway construction -  
*Top:* pattern of trenails derived from ship-building on a short plank used as drain capping;  
*Middle & bottom:* multiple recutting of peg holes for waggonway construction interspersed with residual trenails/trenail holes from ship-building.

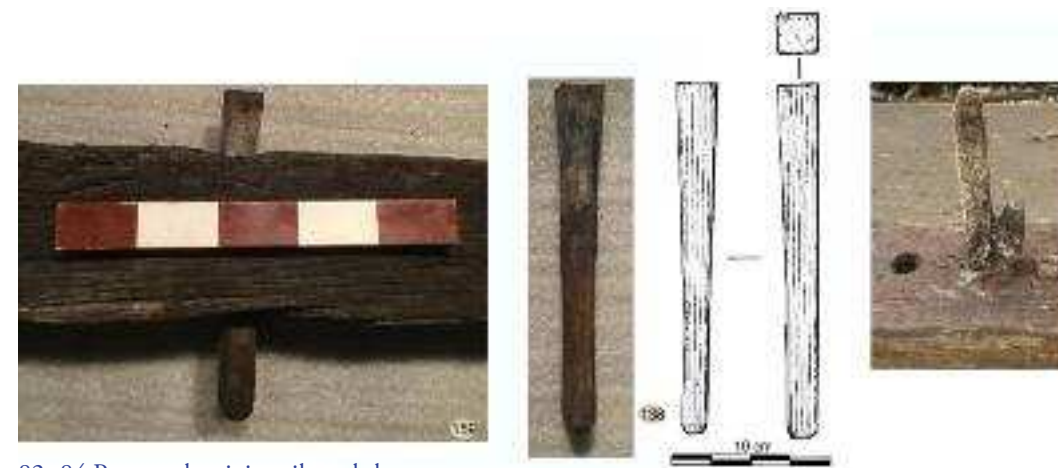
82- 84 Pegs used to join rails and sleepers -

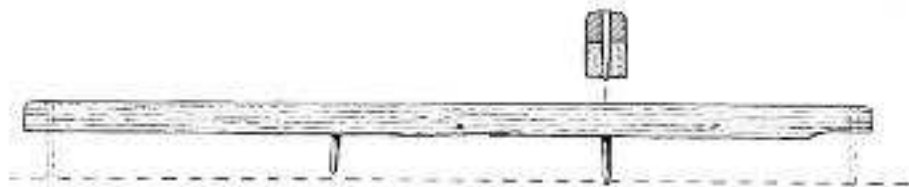
Timber 93. Upper rail on horse-way.

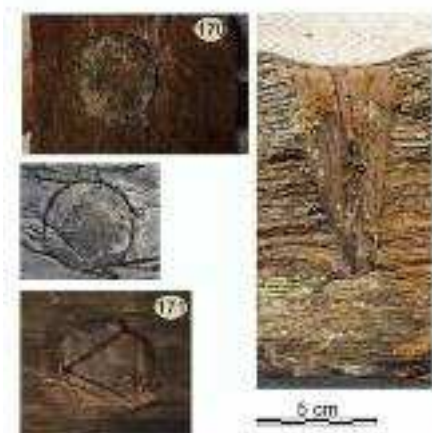
103-106 Details of treenails seen in plan and profile in waggonway timbers, including square and triangular wedges and crossways caulking seen in timber 170. (top left).

Of the 237 timbers recorded from the Neptune Yard excavation, 62 were provisionally identified as being of ship origins on the basis of their curved and tapering shapes, varying thickness or specialised fastenings and joinery. It was impossible to provide more than a tentative identification of original function for the recycled ship timbers but, on the basis of shape alone, two of them may be upper futtocks from the frame of a small vessel such as a sloop, while others appear to be cut from some of the thicker planking found in small to medium sized vessels.

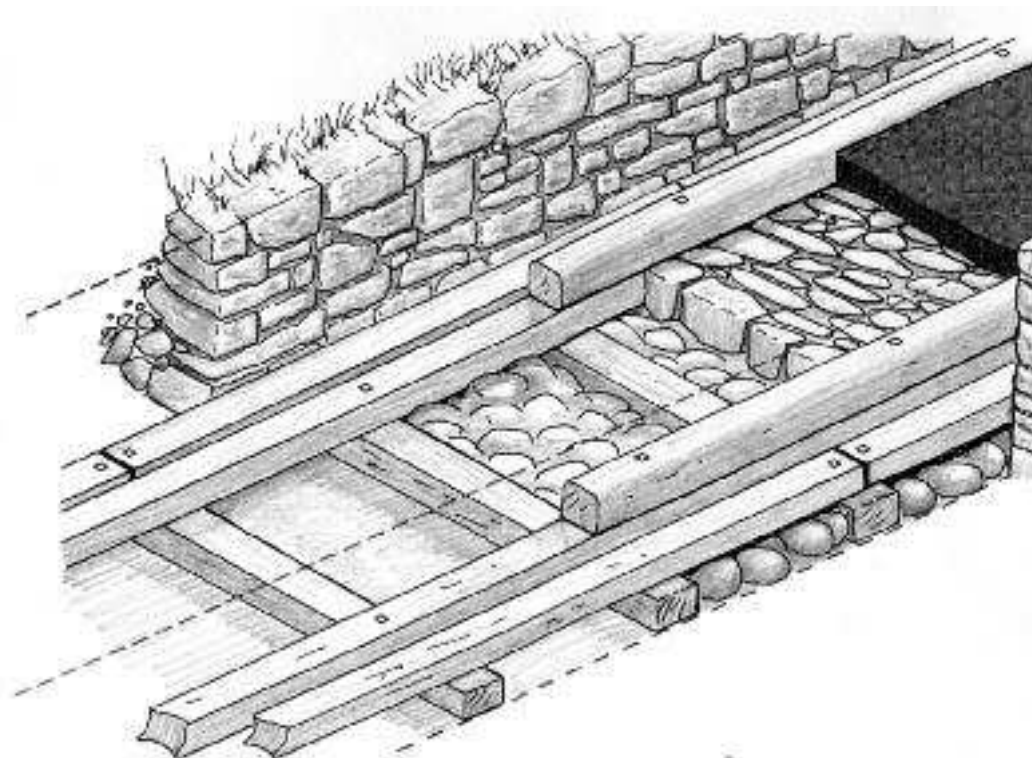
108 Schematic recreation of the original wash pond sideline, showing the outer running rails on sleepers, with the double-rails of the horse-way framing an inner raised cobbled track covered with coal finings. Stone revetment walls form or support the sides of the cutting.

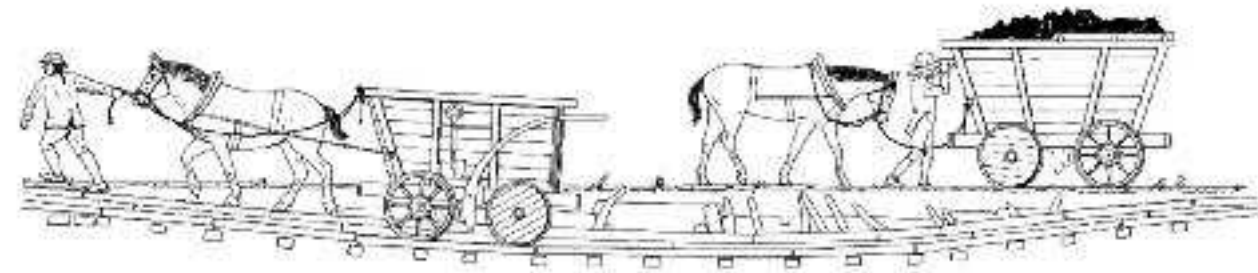
109 Schematic recreation of the wash pond siding, or dip-line, showing wooden-wheeled chaldrons on their way to and from the riverside staites, a coal-laden waggon running downhill with horse walking behind while an empty waggon is pulled out of the wash pond by a draught horse, led by the waggoner.

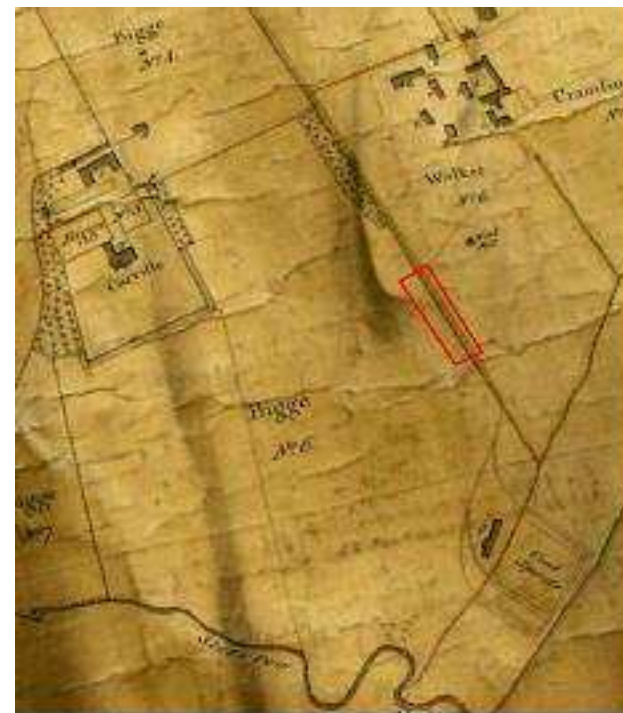
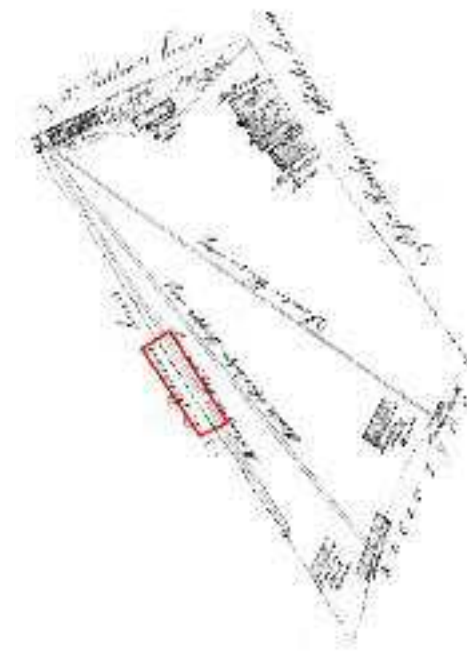
110 & 111 Plans showing the Bigges Main Waggonway in 1800 (Bell's plan of May 1800 for the Dean and Chapter) and 1811 (Buddle Collection 53/1811), showing the site of excavation.

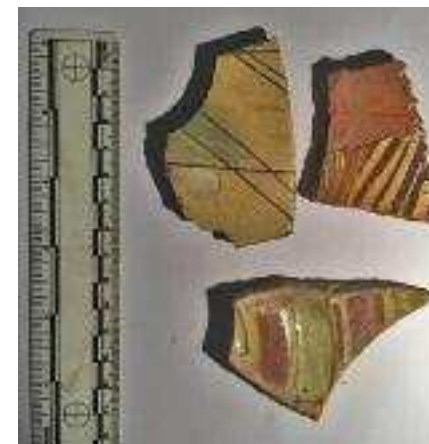
112 Slipware from the construction trench of the culvert and sgraffito-decorated sherd from the construction trench of the timber revetment.

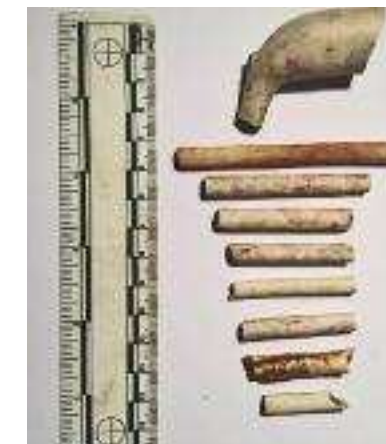
113 Examples of clay pipe stems from deposits overlying the waggonway with a bowl from deposits underlying the main way.

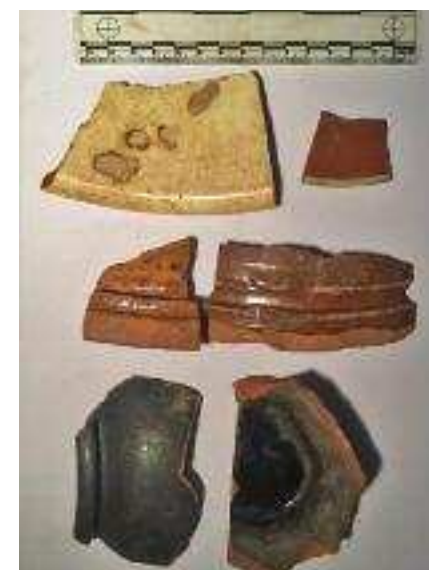
114 Examples of earthenware – black- & transparent-glazed, and slip-coloured - from deposits associated with the waggonway.

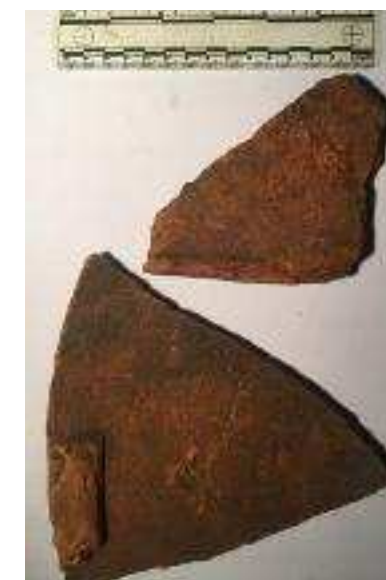
115 Pantile fragments from deposits overlying the west side of the waggonway.
